1. PURPOSE:

This document outlines the procedure for installing the latest software firmware version, v10.75 / v10.85. The primary purpose of this update is to resolve a non- critical programming error that has been identified and has been present in software versions dating back to v10.72 / v10.82.

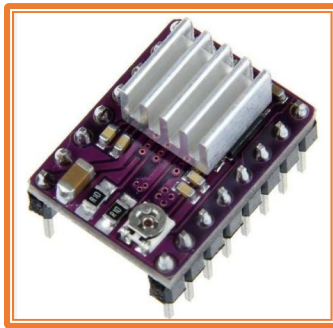
Figure 2: Old drivers (DRV8825). Purple color and grey heat sink. **Not compatible.**

In case your unit has the DRV8825 installed, in order to perform this upgrade you must first install the 'Silent Kit', which is available on our website:

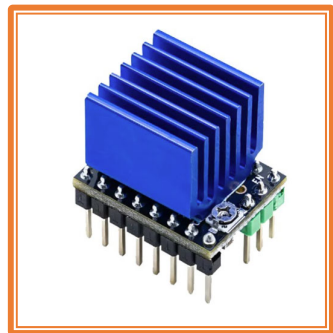
Figure 3: New drivers (TMC2226). Blue color and big blue heat sink. **Compatible.**
