This document describes the procedure for resolving the error that appears on the screen when winding: “Bobbin Motor can be blocked or Stalled.”

FC_16: HOW TO SOLVE THE ERROR “MOTOR BLOCKED OR STALLED”

Revision 3

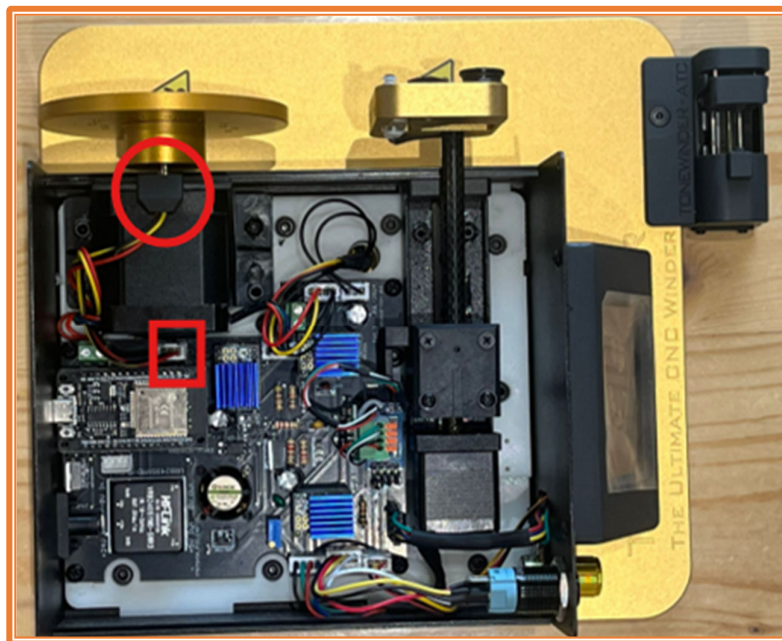
Figure 4: Location of the tachometer sensor.

In most of the cases, this problem will be caused by low sensitivity or malfunction of the tachometer sensor or Hall sensor. This sensor is located above the plate motor and is connected directly to the PCB.

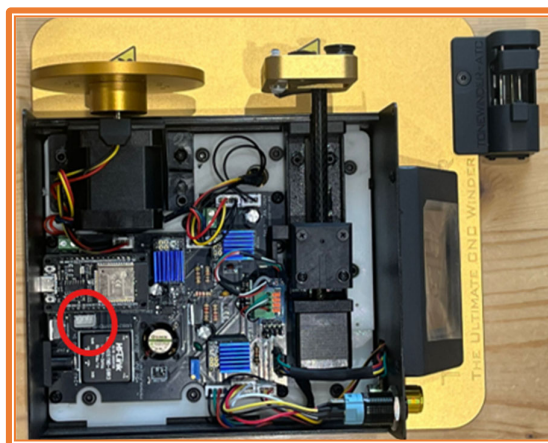
Figure 6: Disconnect Gaussmeter sensor wire from the PCB.

The quickest way to diagnose whether the problem is related to the tachometer sensor is to disconnect the sensor directly from the PCB and perform several tests with the sensor disconnected (it is recommended to check both directions of rotation). If the problem does not reappear, this sensor is the cause of the error.

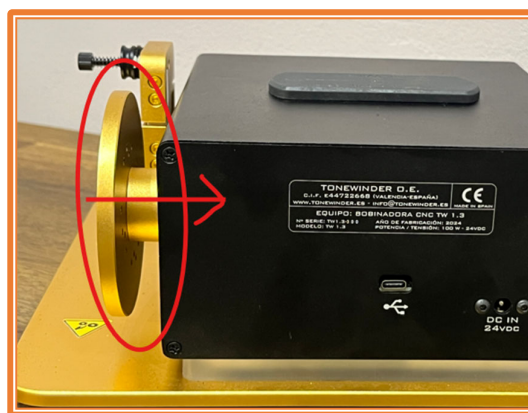
Figure 7: Move the plate closer to the enclosure.

The goal is to adjust the position of the magnet located at the rear of the plate so that it is closer to the tachometer sensor and can detect it correctly. If possible, it is usually sufficient to move the plate 0.5 or 1 mm, as it may otherwise rub against the enclosure.

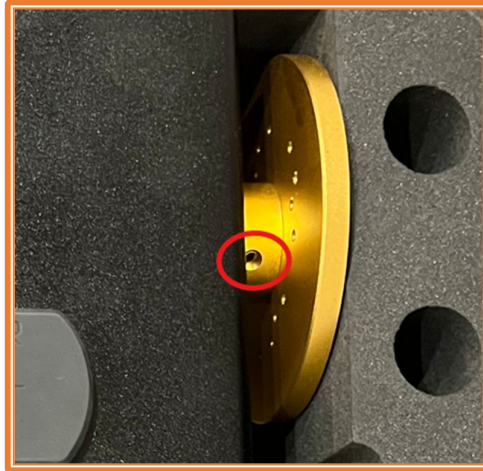
Figure 8: Loosen the screw located in the Plate (Allen screw 2.5 mm).

Loosen the screw located on the plate shaft using a 2.5 mm Allen key.

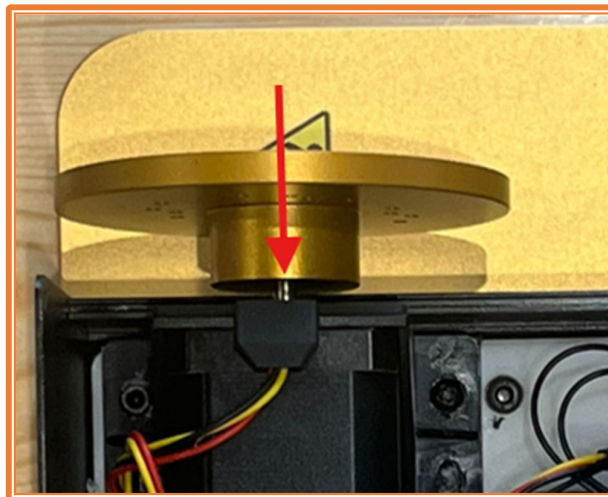
Figure 9: Bring the plate closer to the enclosure without touching the enclosure.

Then, move the plate as close as possible to the enclosure, making sure it does not touch either side of the enclosure. Place the top cover in position to check that it does not touch before continuing with the procedure.

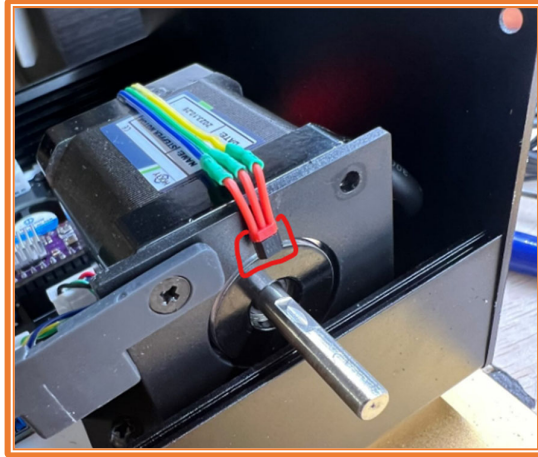
Figure 11: Place the spacer under the sensor.

Loosen the screws on the hall sensor bracket and place the spacer under the sensor to bring the sensor closer to the plate. You can use a piece of wood, plastic, or cardboard measuring 6x6 mm or similar. The idea is to separate the hall sensor from the motor and bring it closer to the plate.

Reposition the sensor holder by tightening the two screws. It is important that these two screws are tightened securely, as they also hold the motor to the motor holder. Do not worry if the sensor holder becomes deformed in the center due to the placement of the spacer.

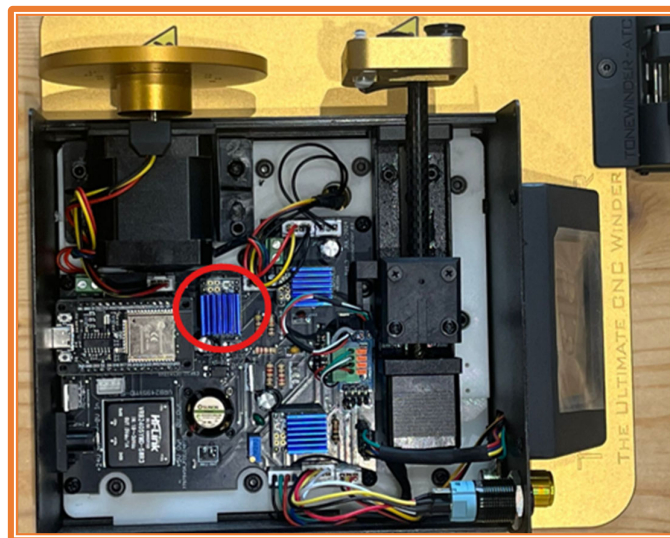
Figure 12: Plate motor control driver.

In a small number of cases, we have found that the problem lies with the motor control driver. This may be due to insufficient power in the driver or an issue with microstep management. You will see that the motor stops and displays an error message.

In some cases, the problem can be solved by increasing the driver current, probably because the plate motor requires more energy to rotate normally. Do not increase the current by more than 10%.

To increase the current, turn the minipotentiometer 5–10 degrees counterclockwise and measure the voltage again. The resulting voltage should be less than 1000 mVDC for TMC2226 drivers and 700 mVDC for DRV8825 drivers.

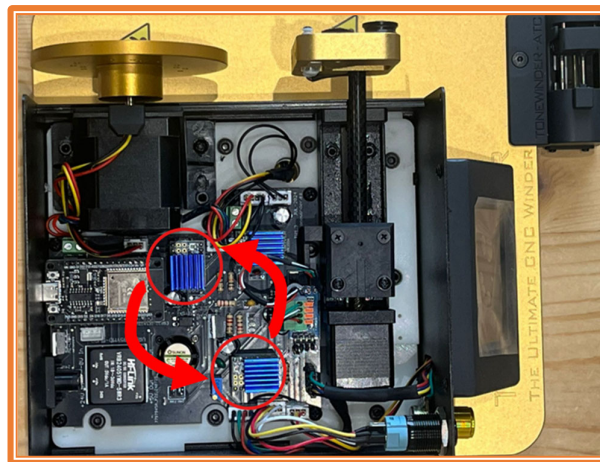
Figure 13: Swap the motor driver for diagnosis.

Maybe the problem could be related with the microstepping of the plate motor driver. In this case, to diagnosis it, we suggest to swap the internal motor drivers of the winder, in order to check if with the other driver (arm motor) the issue is figured it out.

You can use the driver for the arm motor, increasing its current to 800/850 mV for TMC2226 drivers or 600/650 mV for DRV8825 drivers.

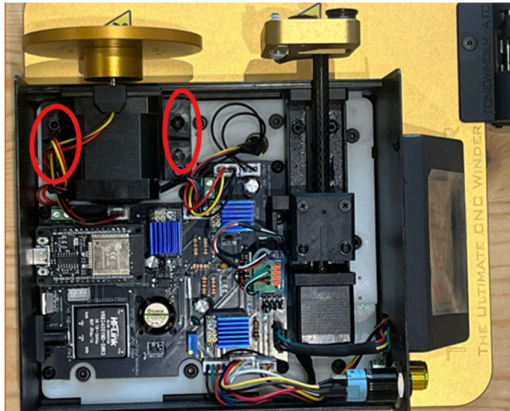
If the problem has not been solved by the previous steps, it may mean that there is a problem with the plate motor and it is actually stopping. Even increasing the current by 5 or 10%, or replacing the driver, will not solve the problem.

In this case you need to replace the plate’s motor. If your unit is under warranty, contact us and we will provide you with a replacement free of charge. If your unit is not under warranty, ask us for a quotation.

- STEP 1: Turn off your winder and disconnect the power cable.
- STEP 2: Remove the top cover and disconnect the Gaussmeter.
- STEP 3: Remove the plate from the motor shaft.
- STEP 4: Disconnect the hall sensor and the motor from the PCB.
- STEP 5: Remove the screws from the motor holder and extract the assembly:
