This document describes the procedure for resolving the error that appears on the screen when winding: “Bobbin Motor can be blocked or Stalled.”

FC_16: HOW TO SOLVE THE ERROR “MOTOR BLOCKED OR STALLED”

Revision 3

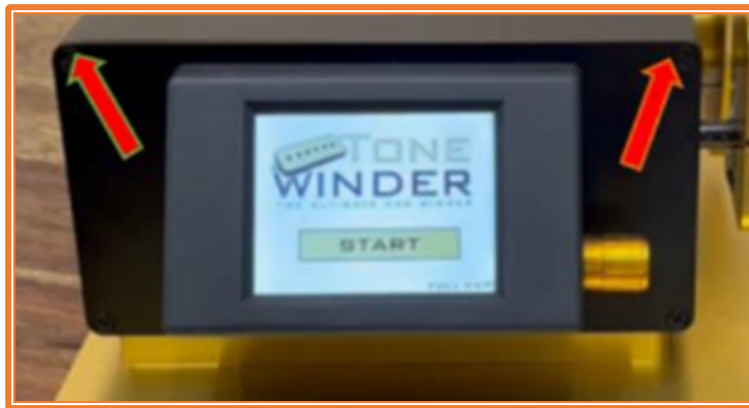
Figure 5: Remove the top screws from the front and rear cover (x4).

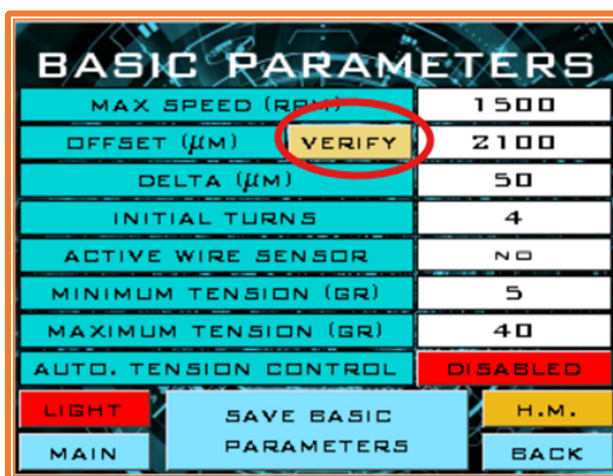
Figure 10: Set up the offset after readjusting the plate.

One consequence of moving the plate is that we will need to adjust the OFFSET parameter because the distance from the plate plane to the home sensor has changed. Follow the procedure described in section 6.4.1 of the Operator's Manual to do this. You can also watch a video by clicking this link:
